### **PROJECT #153K BEHAVIOR OF CORRODED PIPELINES UNDER CYCLIC PRESSURE**

Report Title: Project #153K Behavior of Corroded Pipelines under Cyclic Pressure	
Report Number: R8928	Project SAP Code: 1/07620

This report presents the results for Project #153K, "Behavior of Corroded Pipelines Under Cyclic Pressure".

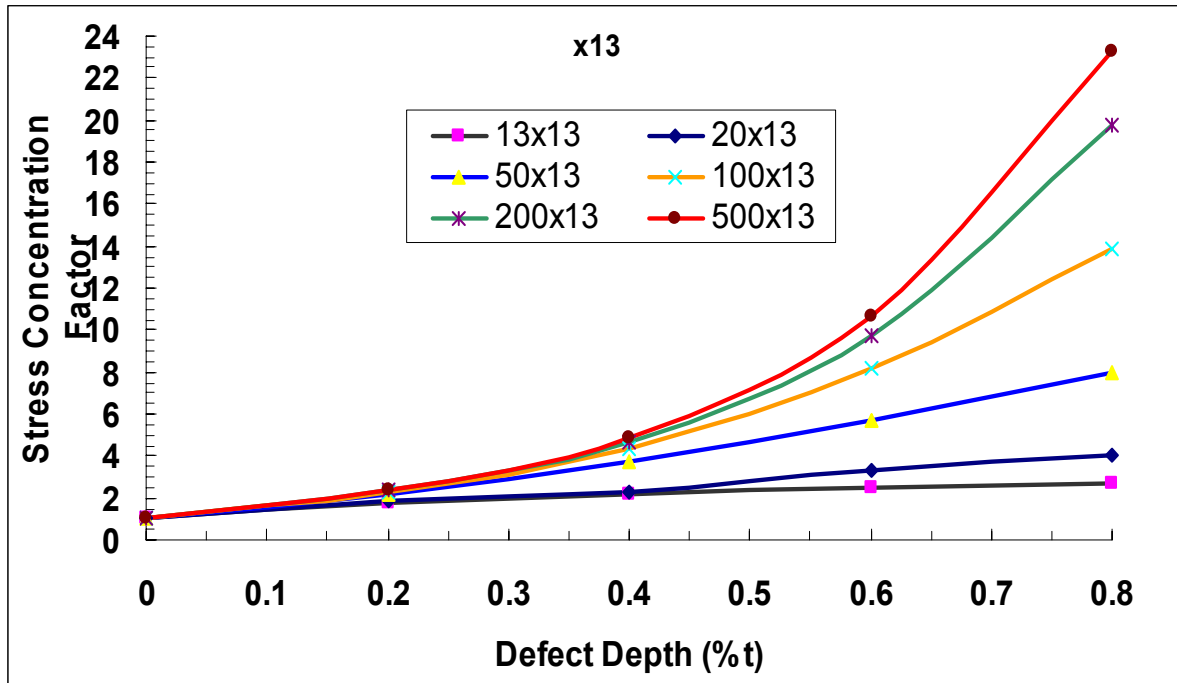
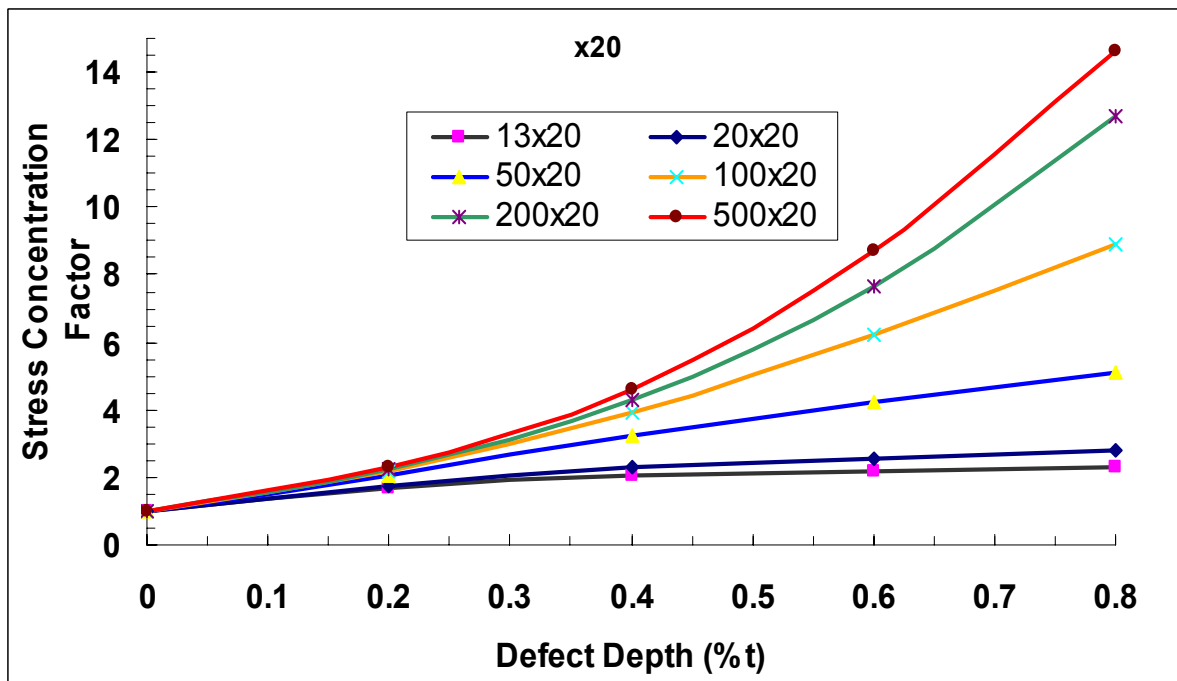
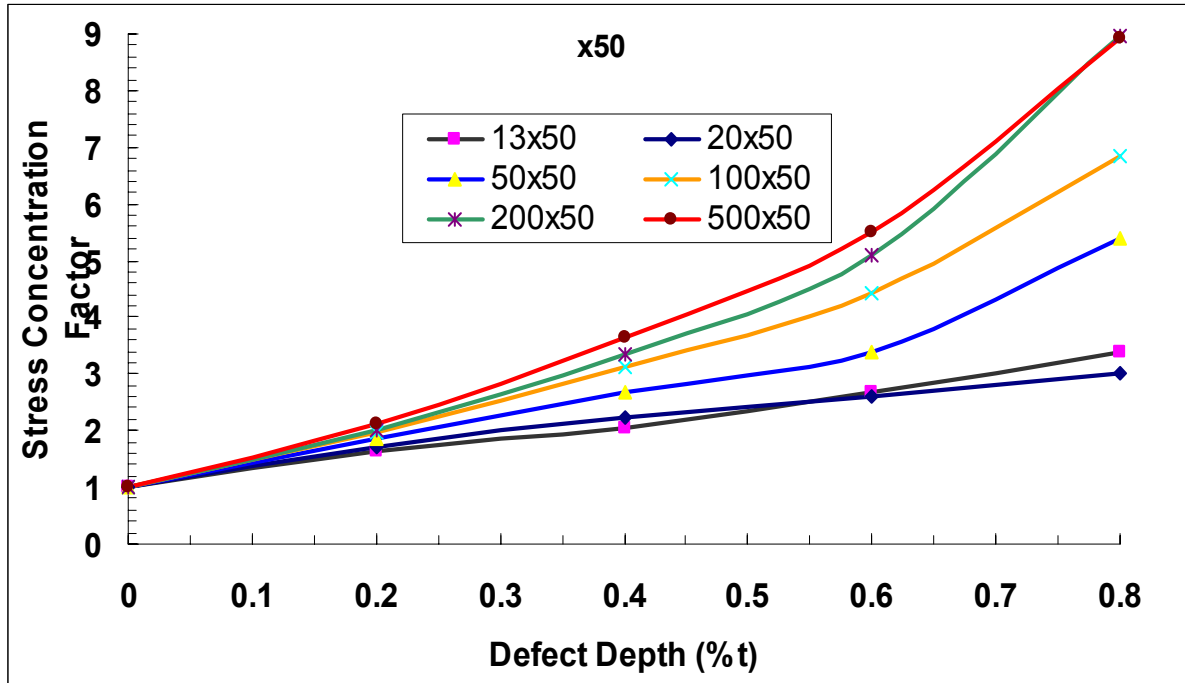
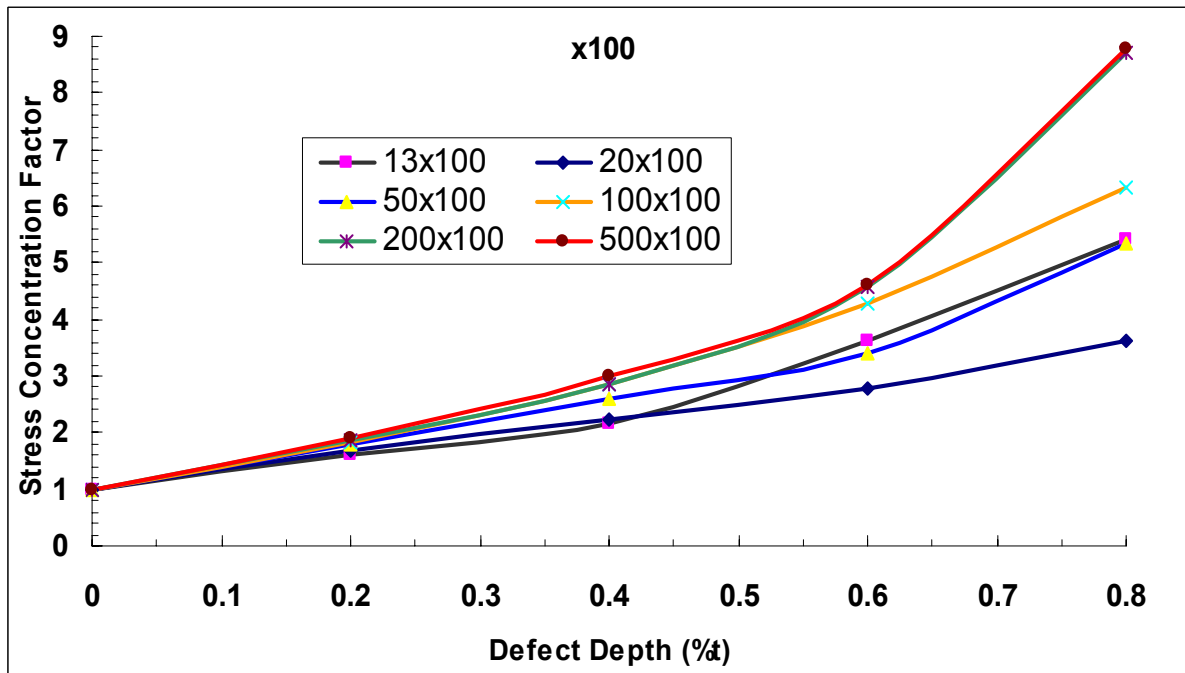
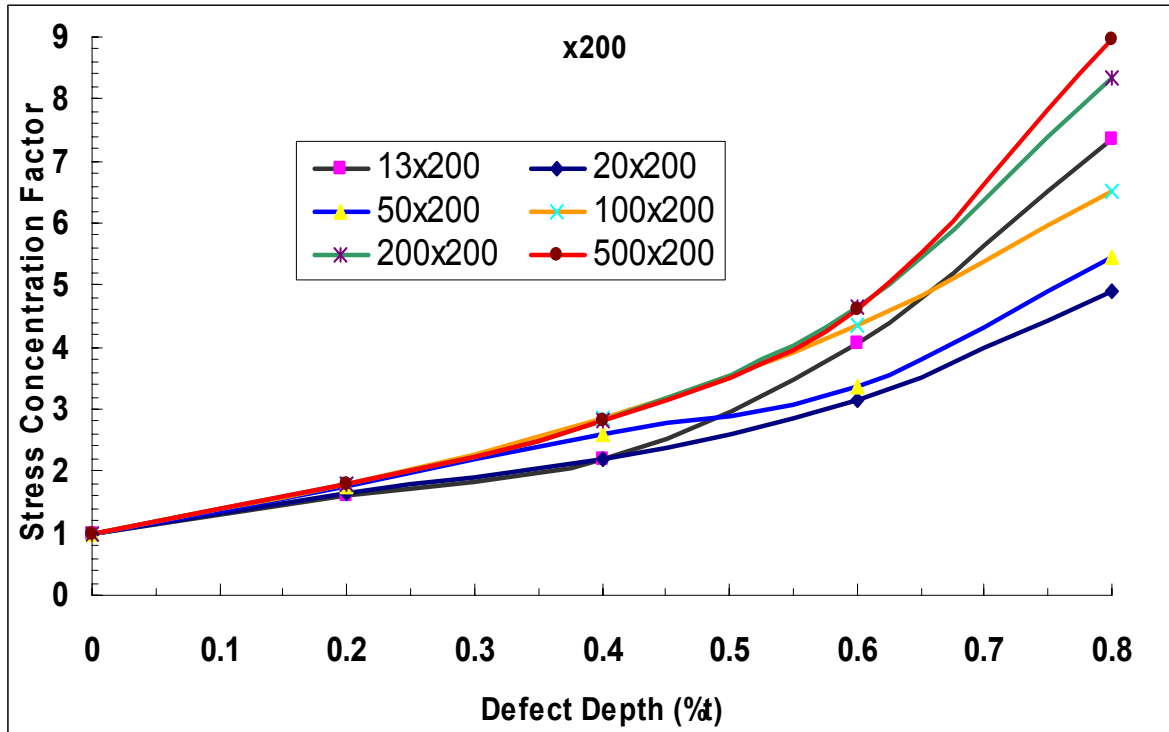
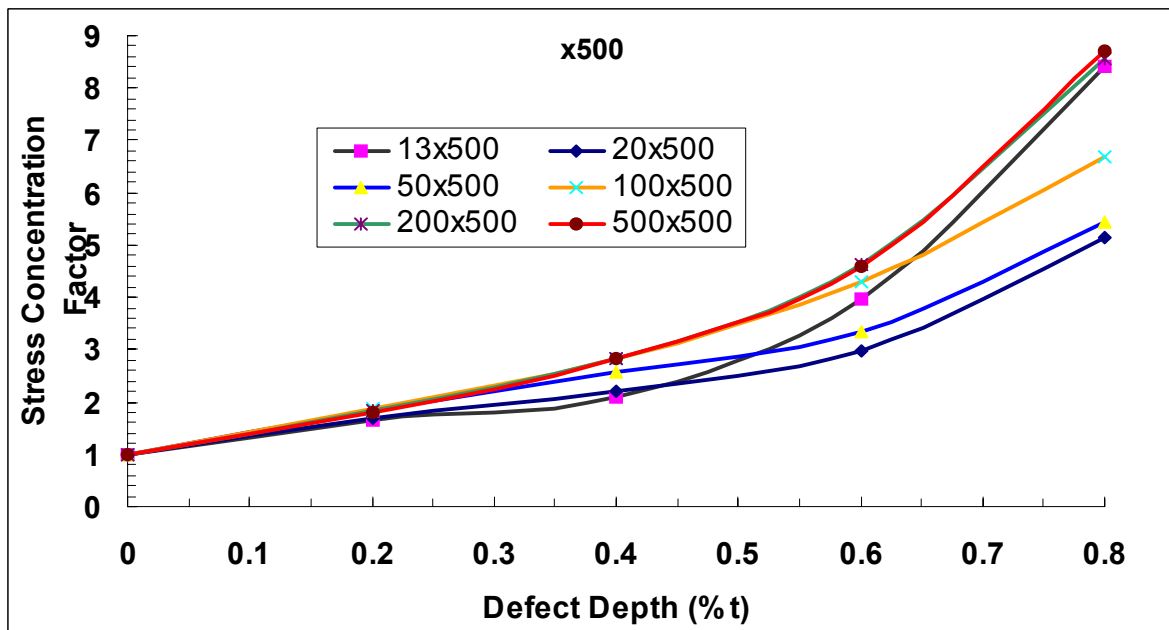
Figure 14 – SCFs of 914.4 mm x 12.7 mm Pipe with Variation of Corrosion Depth

c): with CCL = 50 mm and ACL = 13 mm, 20 mm, 50 mm, 100 mm, 200 mm and 500 mm

d): with CCL = 100 mm and ACL = 13 mm, 20 mm, 50 mm, 100 mm, 200 mm and 500 mm

e): with CCL = 200 mm and ACL = 13 mm, 20 mm, 50 mm, 100 mm, 200 mm and 500 mm

f): with CCL = 500 mm and ACL = 13 mm, 20 mm, 50 mm, 100 mm, 200 mm and 500 mm

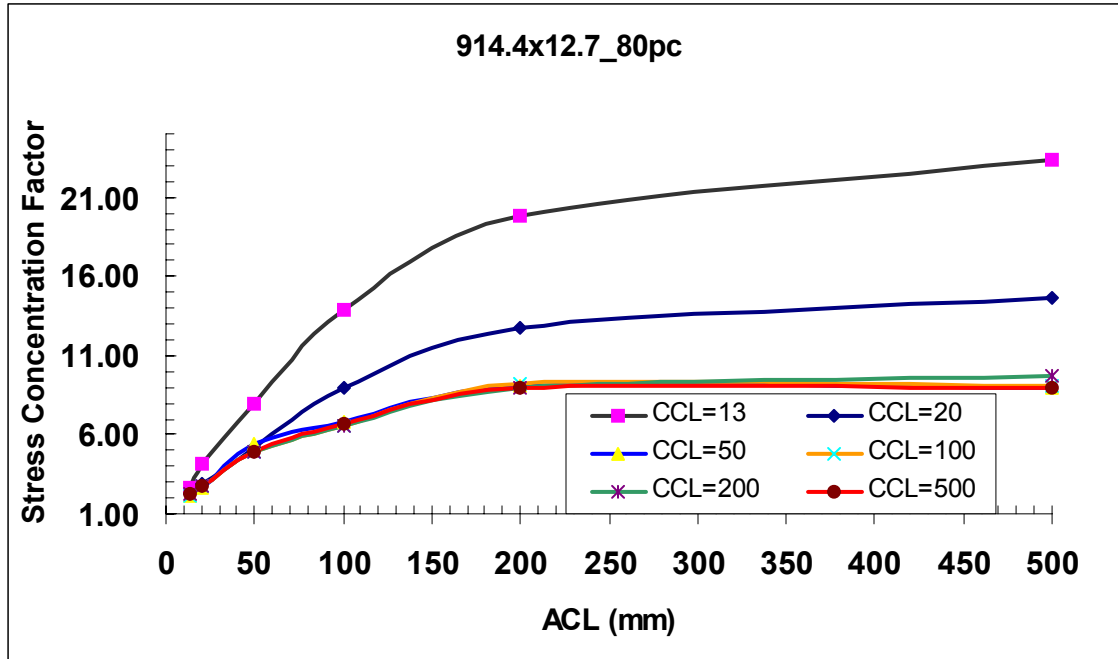
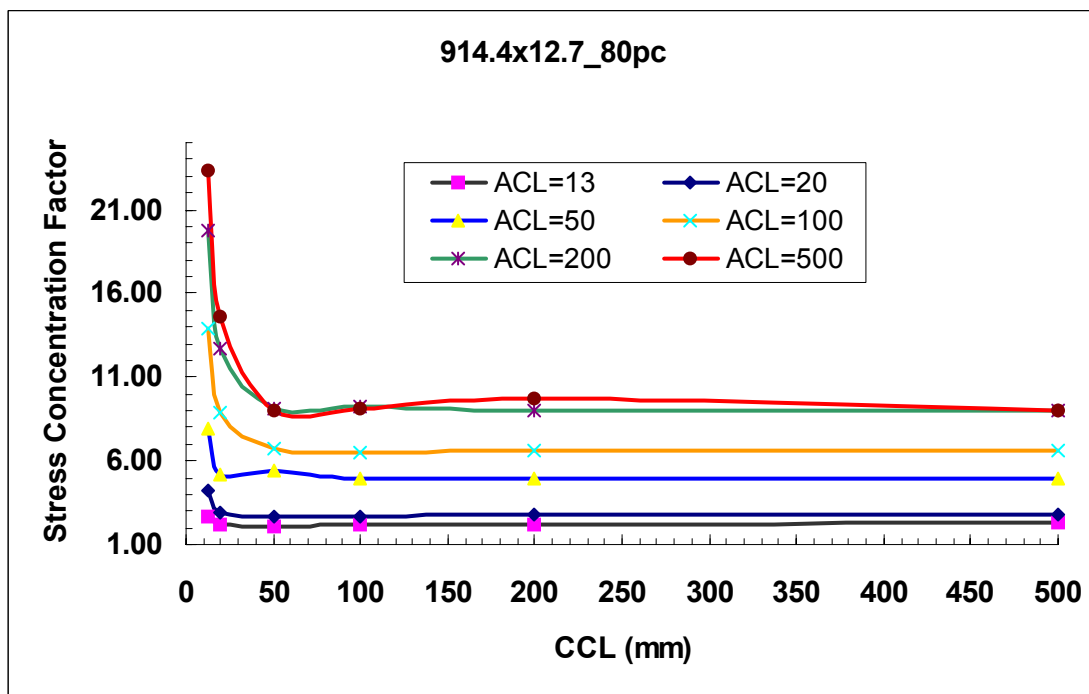
Figure 15 – SCFs of 914.4 mm x 12.7 mm Pipe with CD = 80%t and r/t = 1 and without 'capped end force'

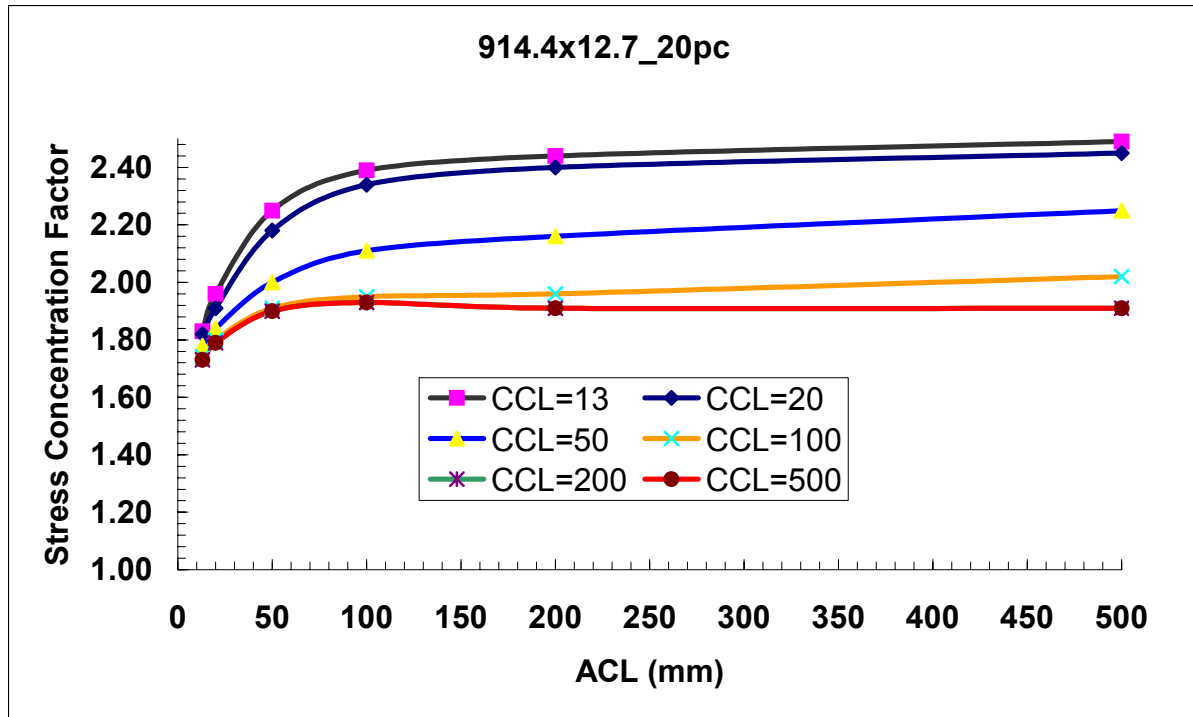
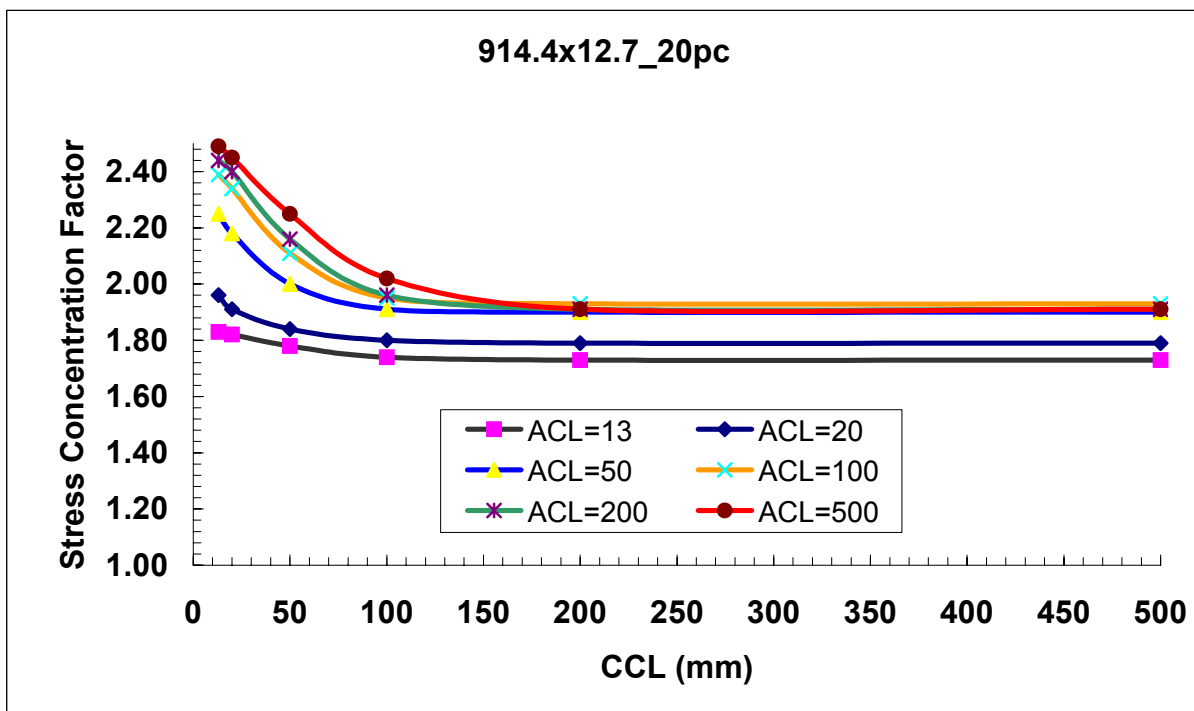
Figure 16 – SCFs of 914.4 mm x 12.7 mm Pipe with CD = 20%t and r/t = 0.5

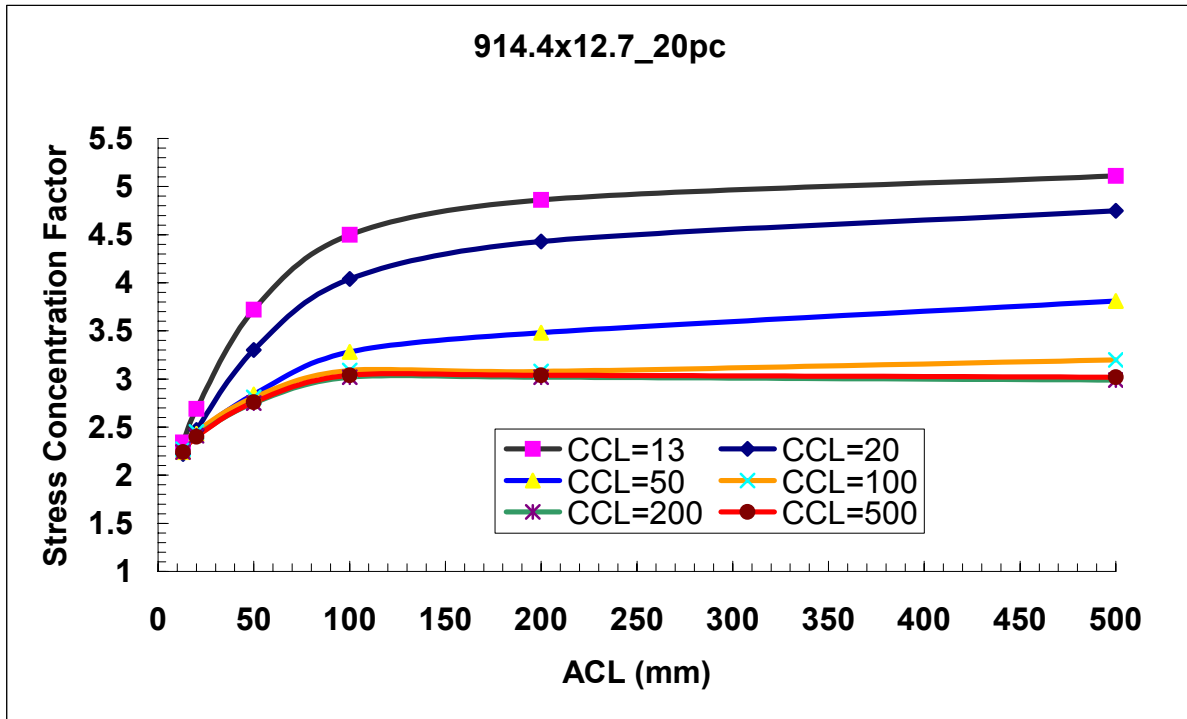
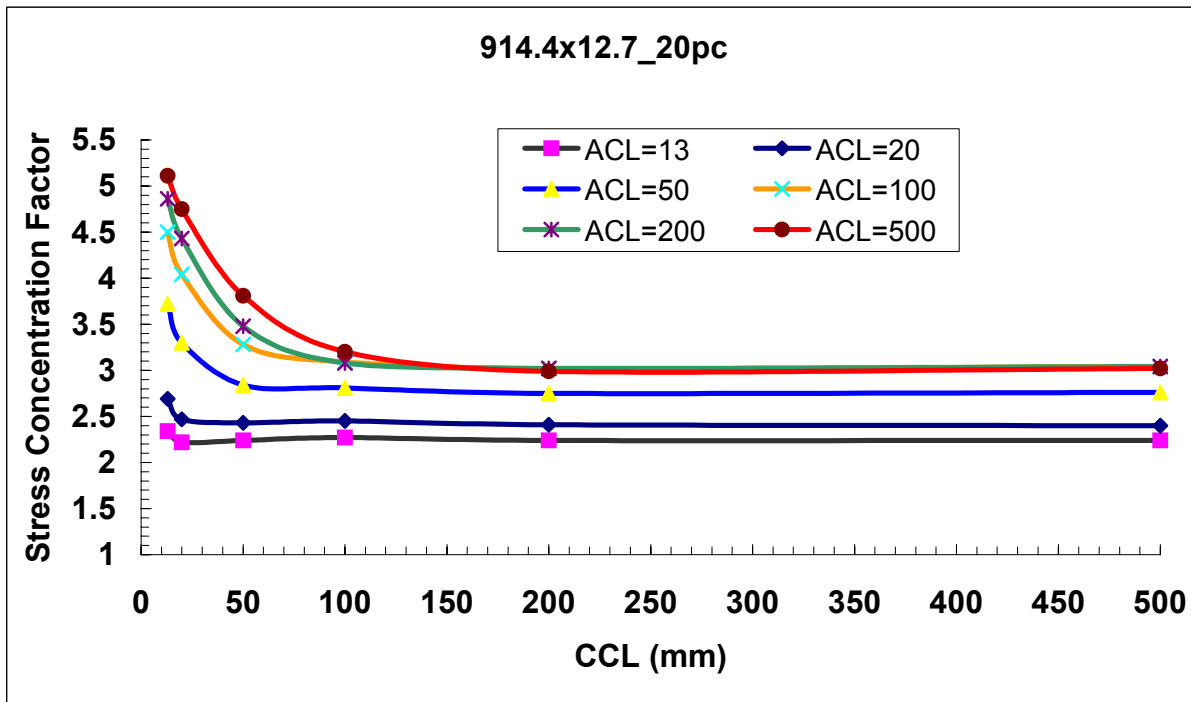
Figure 17 – SCFs of 914.4 mm x 12.7 mm Pipe with CD = 40%t and r/t = 0.5

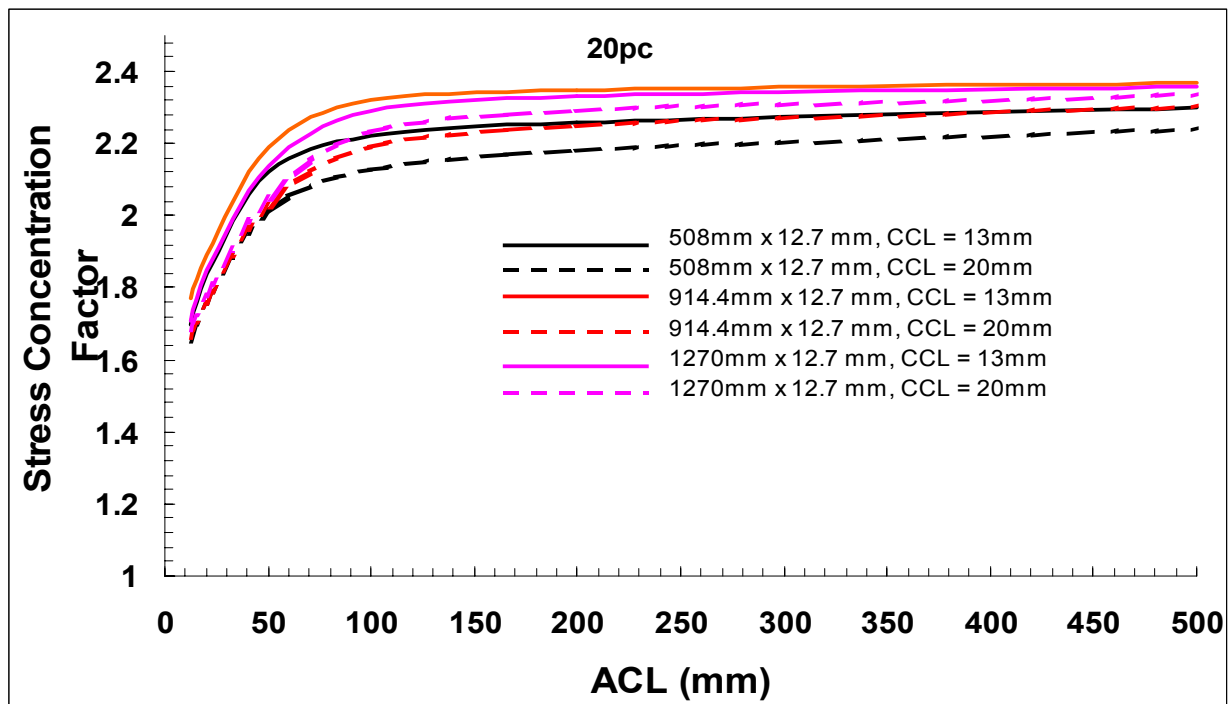
Figure 18 – SCF for 508 mm x12.7, 914.4 mm x 12.7 mm and 1270 mm x 12.7 mm Pipe with CD = 20%t ( $r/t = 1$ )

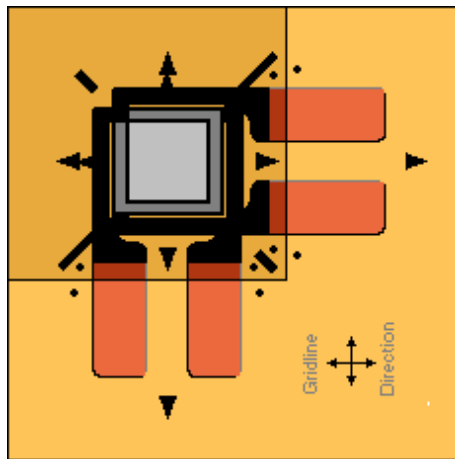
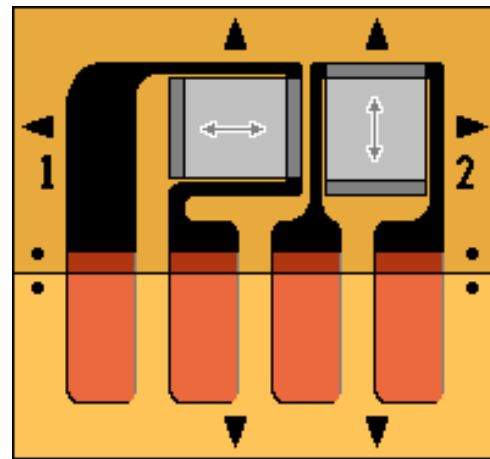
Type 1: CEA-06-062WT-350

Type 2: CEA-06-062UT-350

Figure 23. Strain gauge rosettes used to measure the pipe axial and circumferential strains in the defect area.

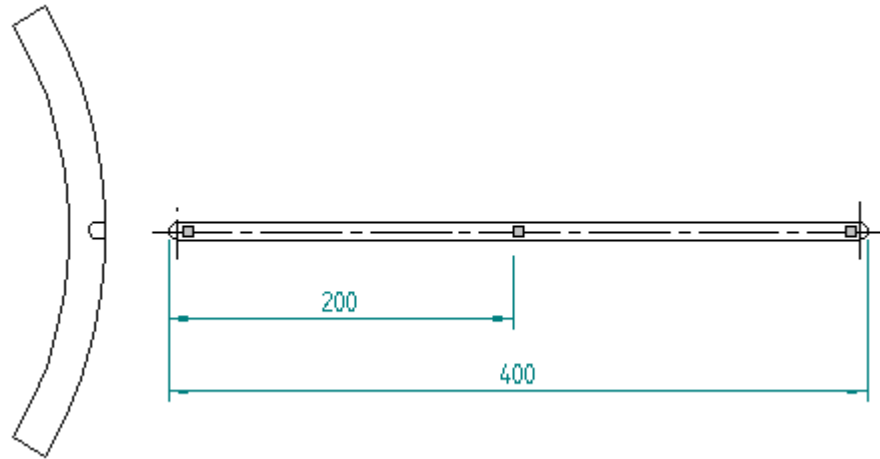
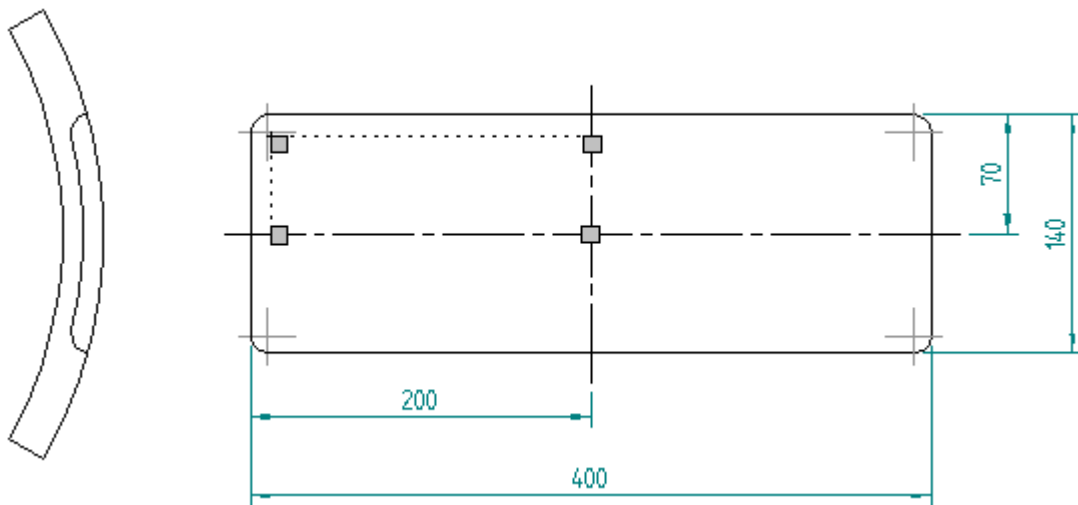
(a) Groove defect

(b) Patch defect

Figure 24. Strain gauge locations within the groove and patch defects.

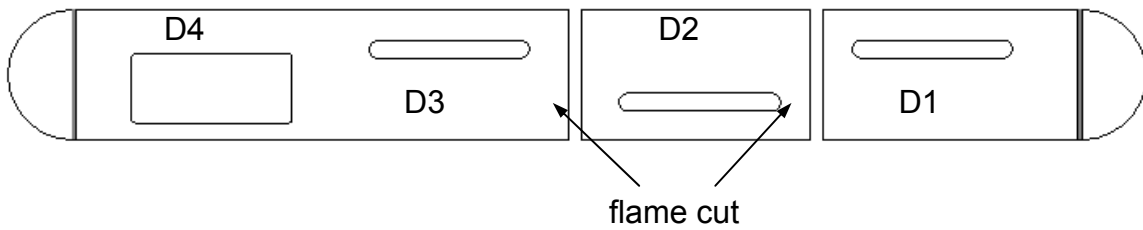
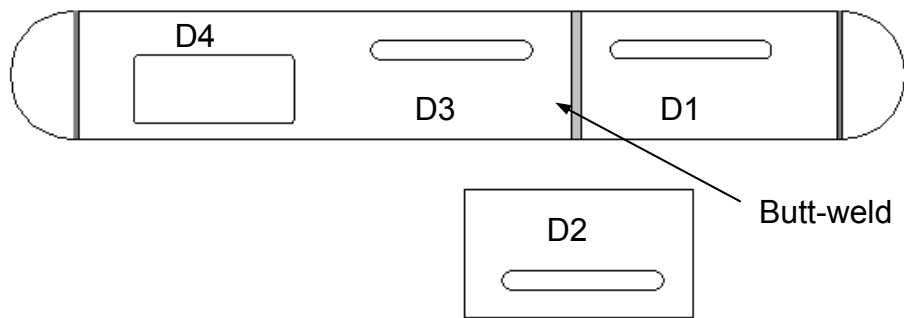
(b) removal of defect D2 via flame cutting (cutting process cuts a weld prep onto the ends of the pup pieces containing defects D1, D3 and D4)

(c) defect D2 is extracted and the two vessel ends are butt welded together. Pressure cycling is then resumed.

Figure 25. Illustration of repair methodology (not to scale).

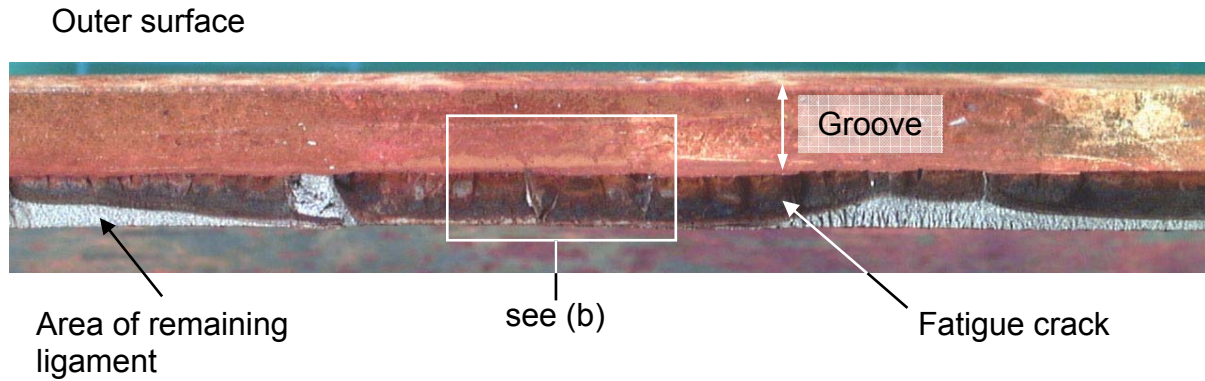
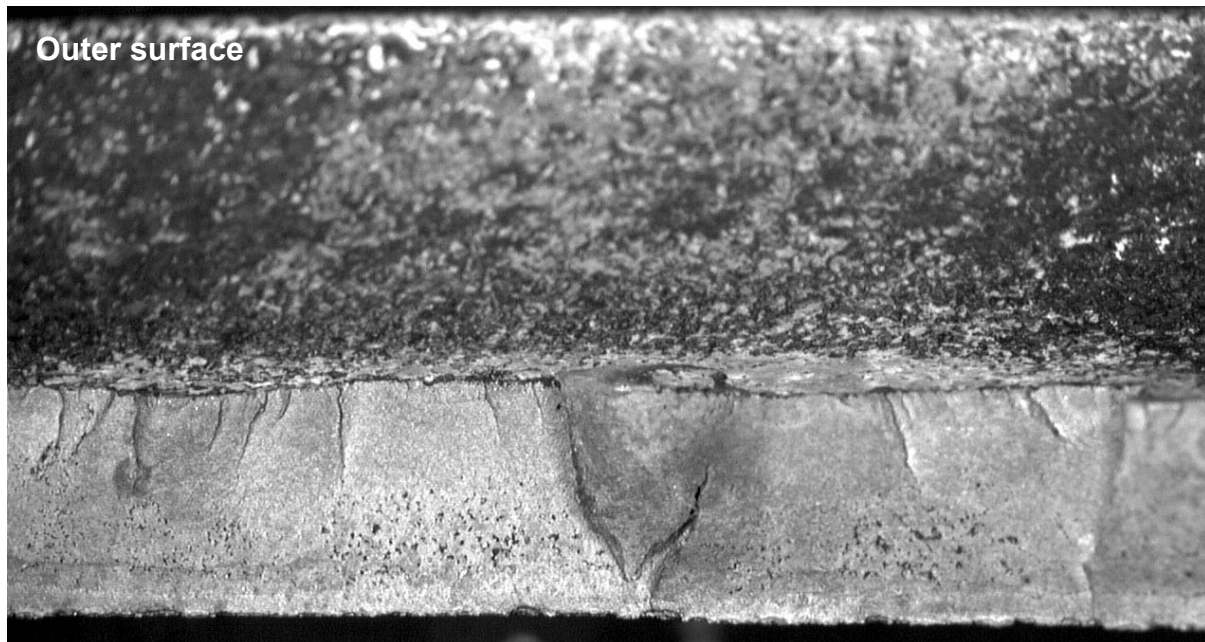
(a) Multiple crack initiation sites along outer surface of defect, which eventually coalesce to form one large fatigue crack

(b) Cleaned up image of typical crack initiation site at location of through wall breach, as enveloped in (a) above.

Figure 26. Defect D3: Stereo optical microscope images of crack face features.

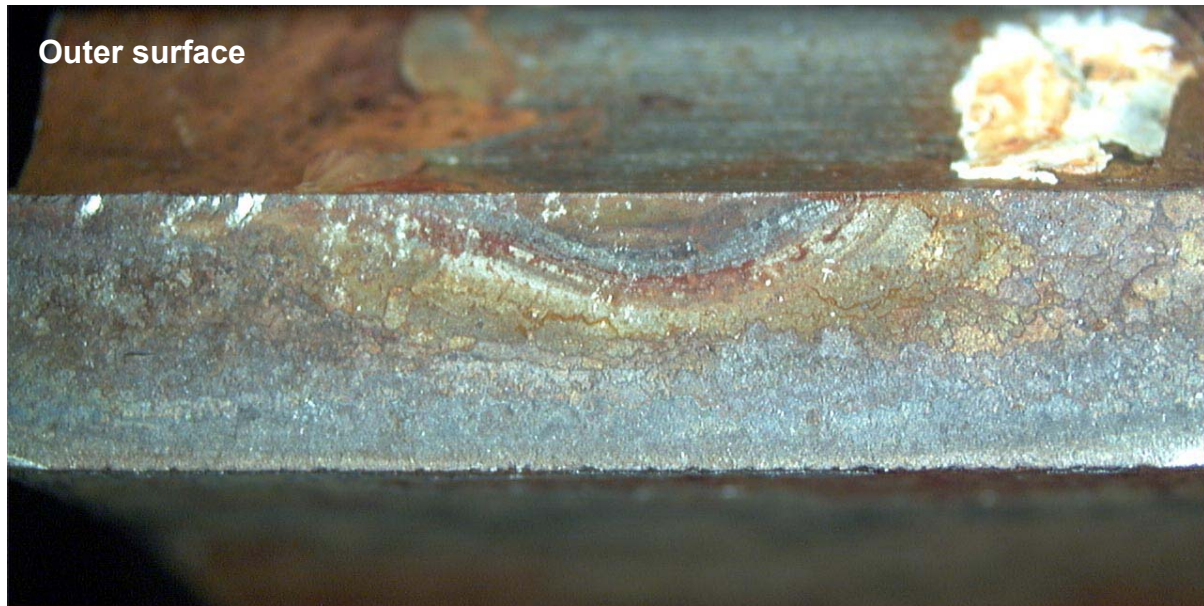
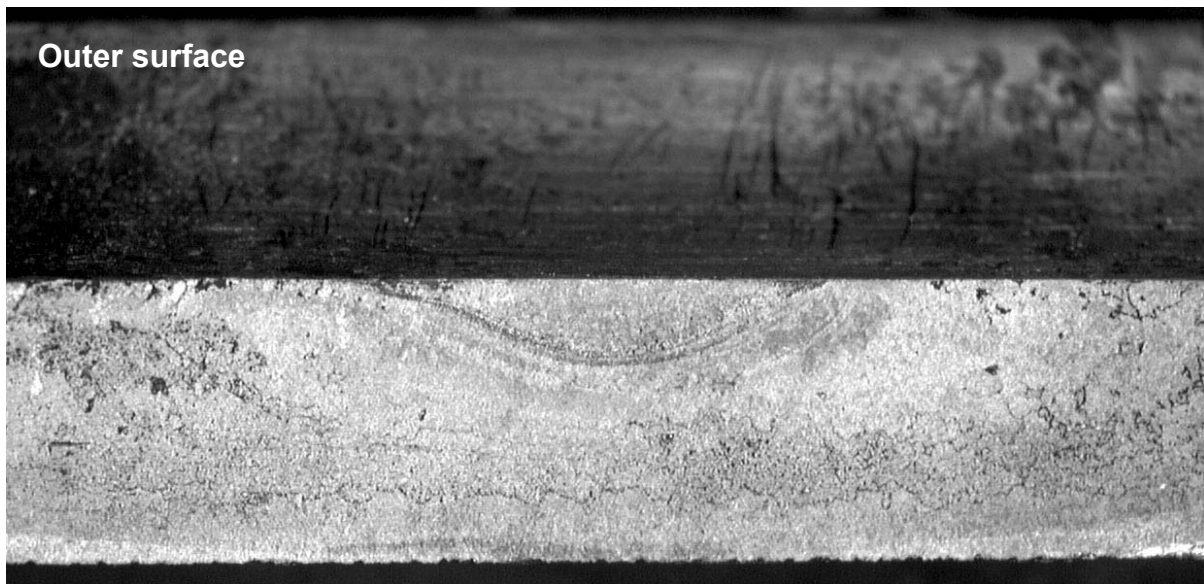
(a) Crack initiation site along outer surface of defect

(b) Cleaned up image of crack initiation site and location of through wall breach. Beach markings clearly visible, showing crack propagation from the outer to the inner surface (top to bottom in image).

Figure 27. Defect D2: Stereo optical microscope images of crack face features.

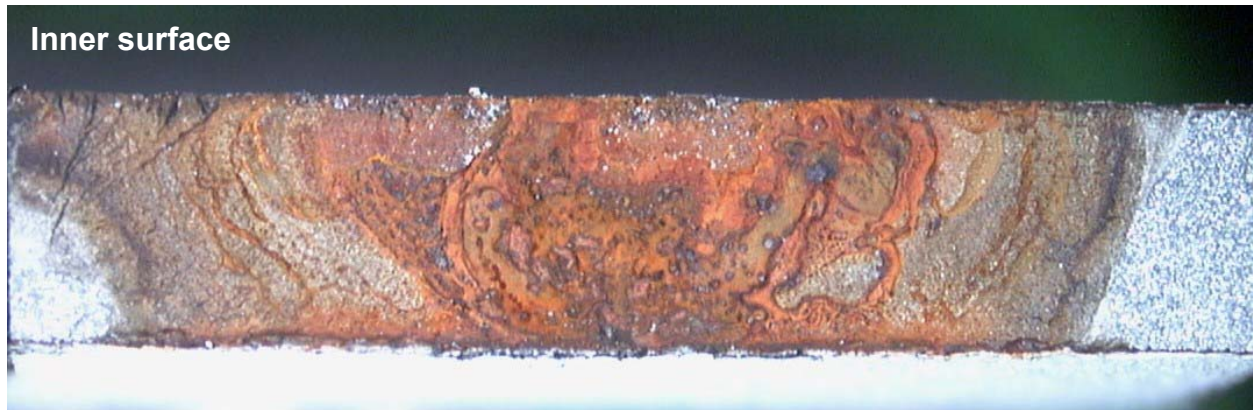
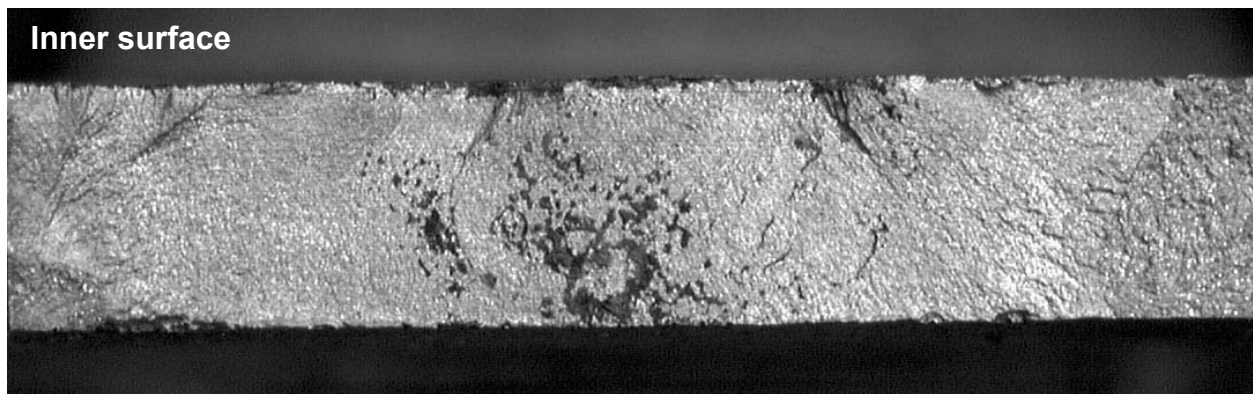
(a) Crack initiation site along inner surface of defect

(b) Cleaned up image of multiple crack initiation sites and location of through wall breach. Crack propagation from the inner to the outer surface (top to bottom in image).

Figure 28. Defect D4: Stereo optical microscope images of crack face features.

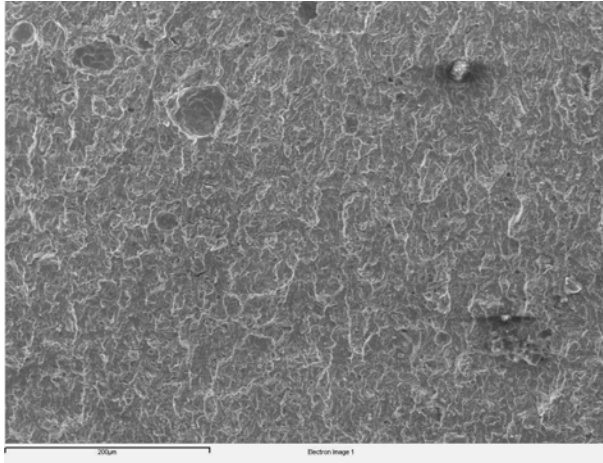
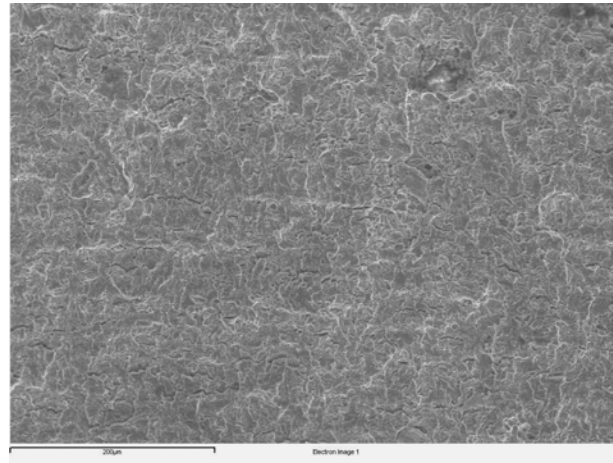
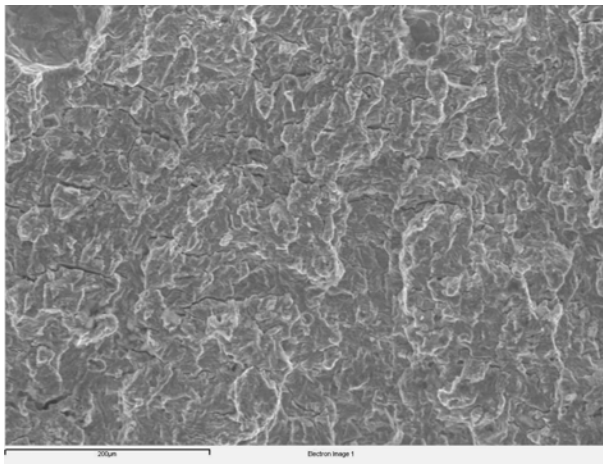
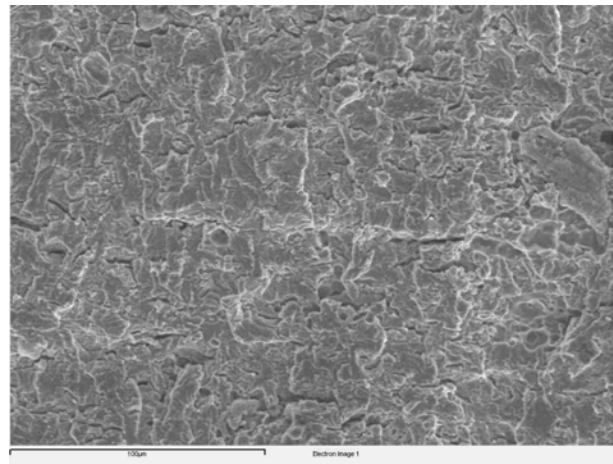
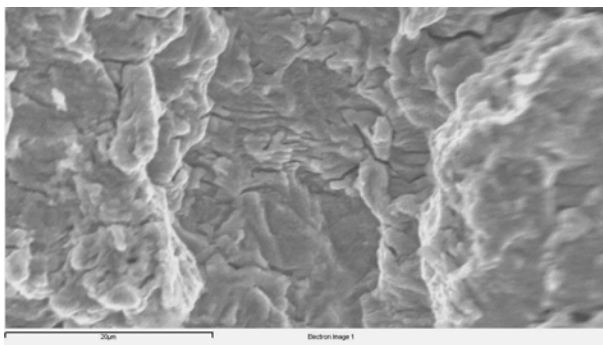
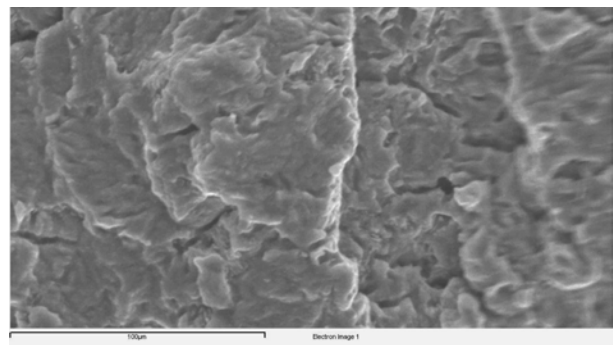
Fatigue crack surface features – **outer**, 200µm scale

Striations – **outer**, 20µm scale

Figure 29. Defect D3: Scanning electron microscope images (crack growth direction is top to bottom in all images).

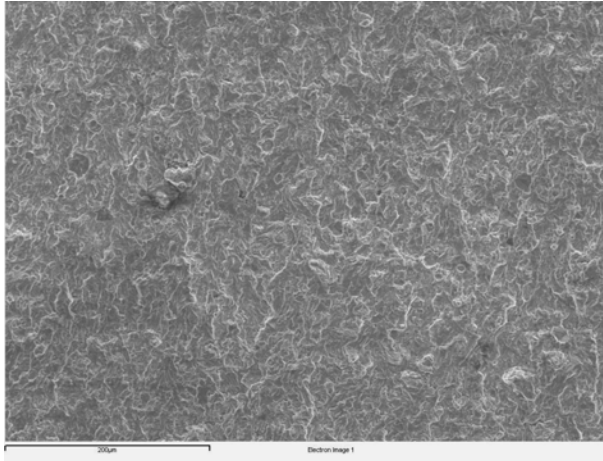
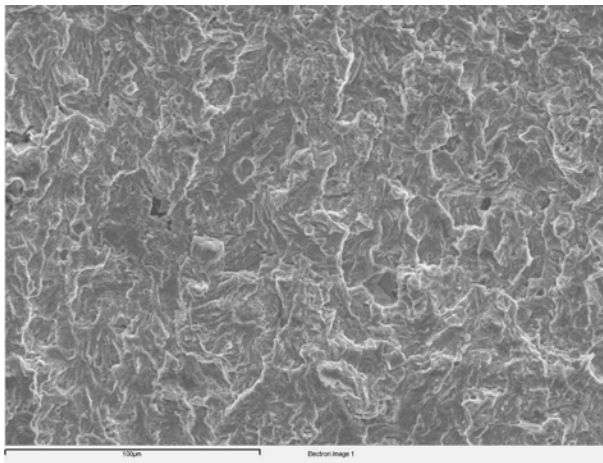
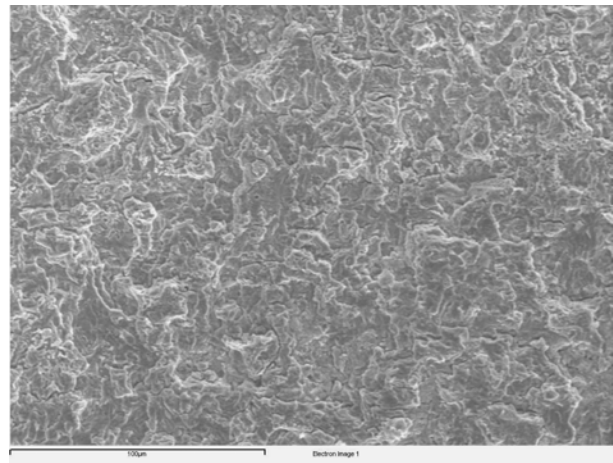
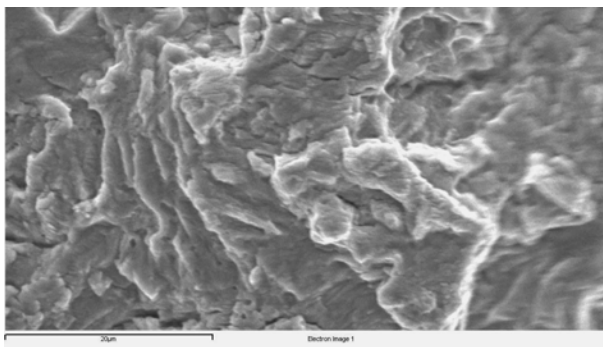
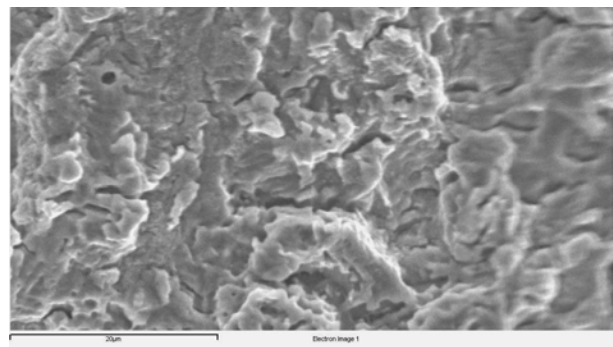
Striations – **outer**, 20 $\mu$ m scale

Figure 30. Defect D2: Scanning electron microscope images (crack growth direction is top to bottom in all images).

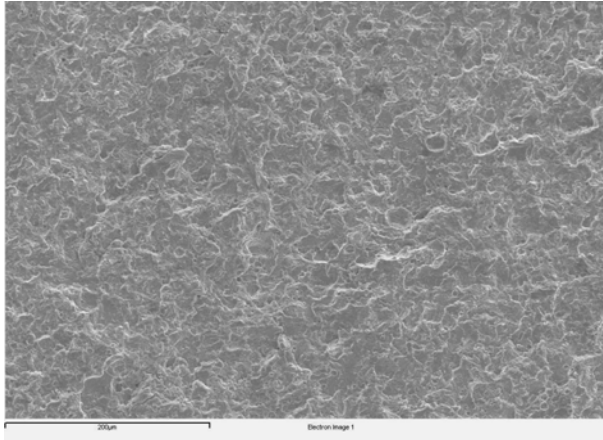
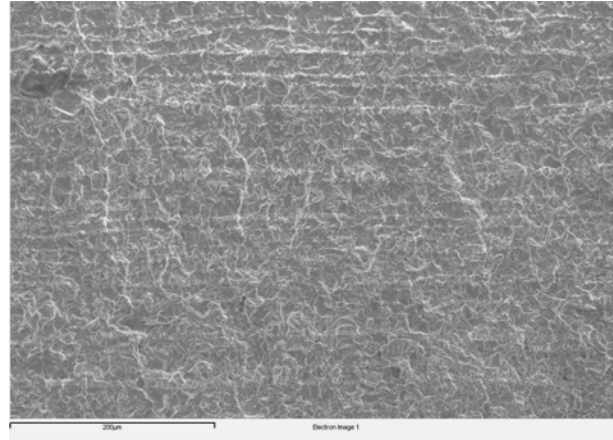
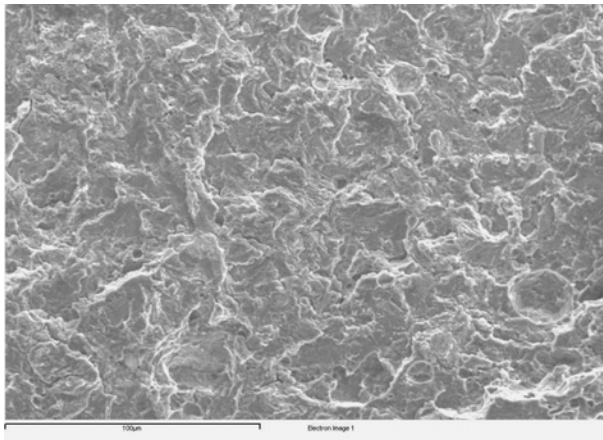
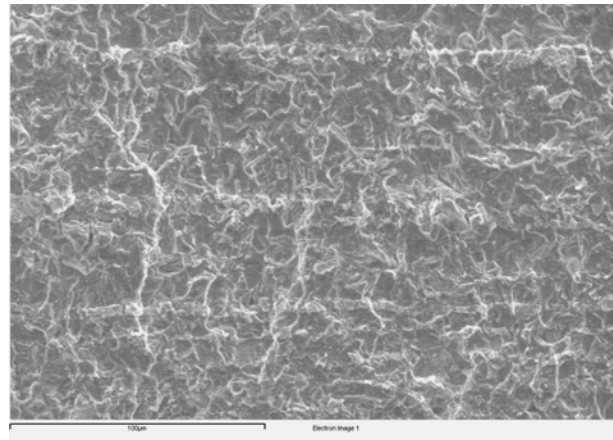
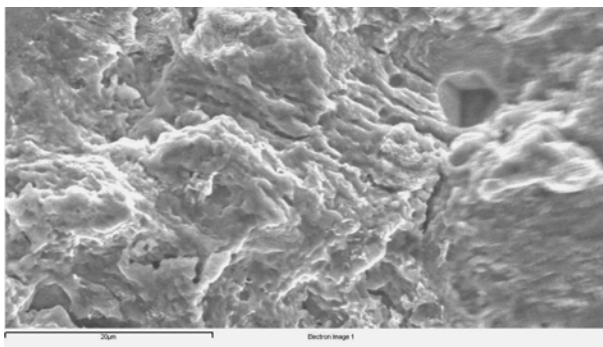
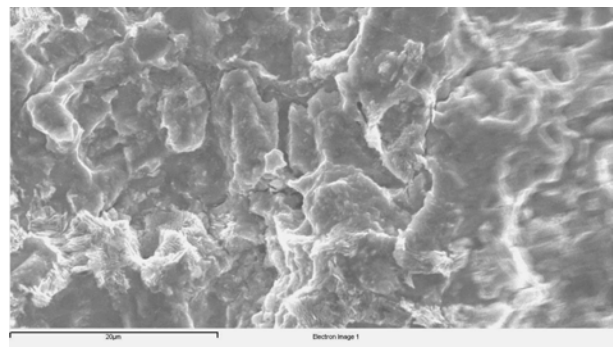
Striations – **inner**, 20µm scale (not as clear as on **outer** surface)

Figure 31. Defect D4: Scanning electron microscope images (crack growth direction is top to bottom in all images).

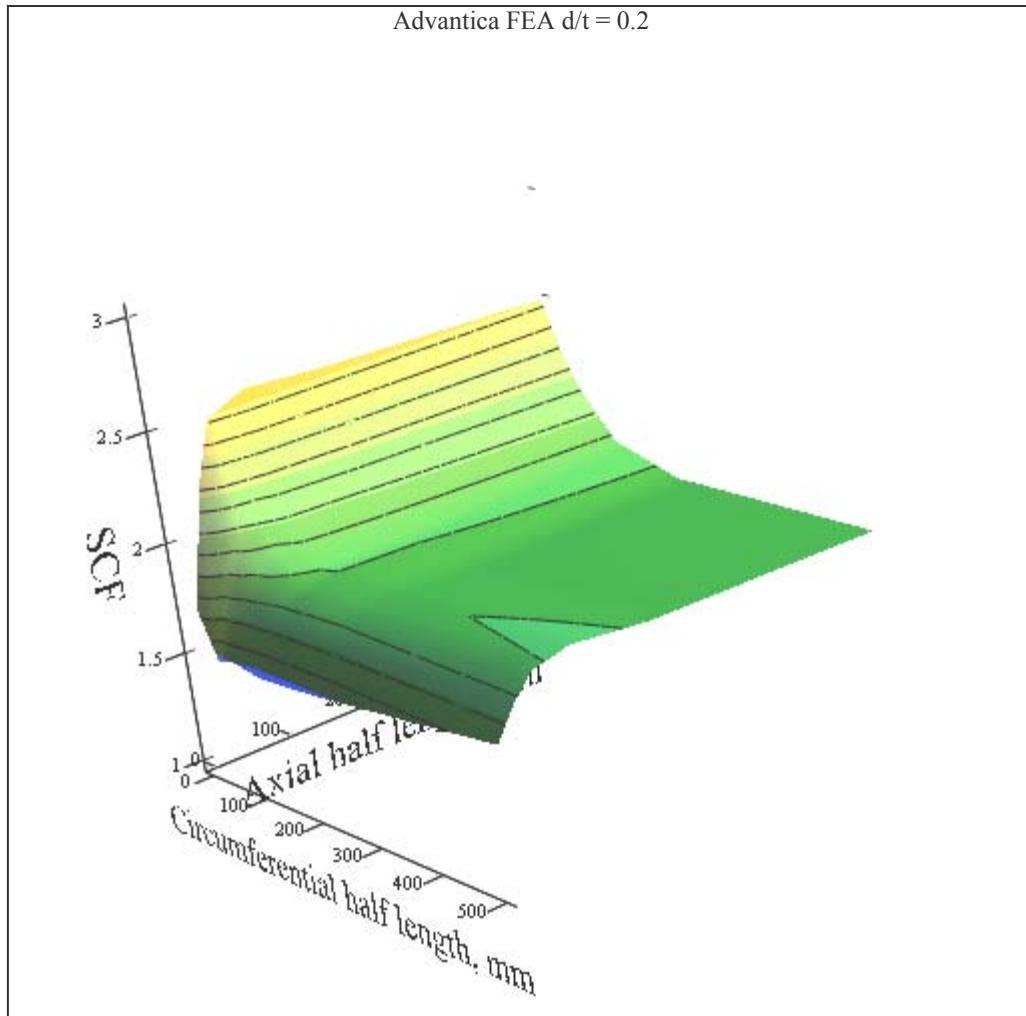
Figure 32. Surface plot of SCF results for a defect depth  $d/t=0.2$
